ROOFRITE

PREMIUM PERFORMANCE ROOF COATING SYSTEMS

Application Guide

Version 2.0

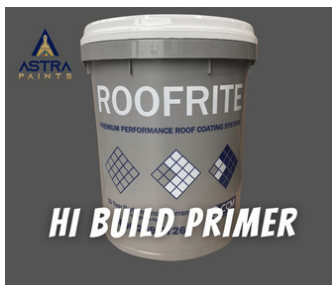
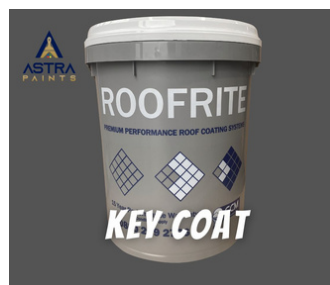
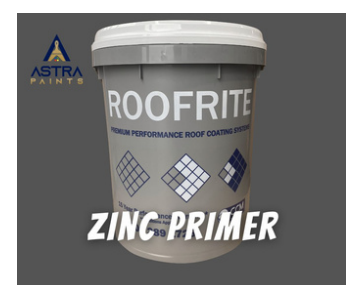
4. After a minimum of 2 hours, cut a cross (x) in the ROOFRITE Topcoat and firmly apply a strong sticky tape over the cross cut.
5. Immediately tear the tape off. If the paint comes off easily, then another adhesion test can be done using ROOFRITE Zinc Prime.
