ROOFRITE

PREMIUM PERFORMANCE ROOF COATING SYSTEMS

Application Guide

Version 2.0

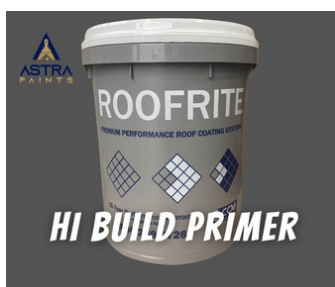
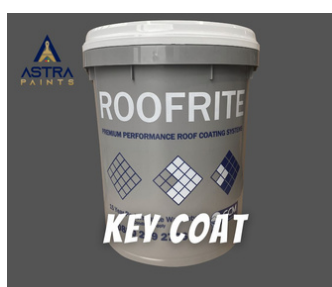
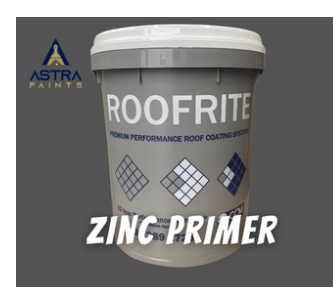
4. After a minimum of 2 hours, cut a cross (x) in the ROOFRITE Topcoat and firmly apply a strong sticky tape over the cross cut.
5. Immediately tear the tape off. If the paint comes off easily, then another adhesion test can be done using ROOFRITE Zinc Prime.

6. If the ROOFRITE Galvanised Iron Primer comes off easily, then an adhesion test with CCM Anti Corrosive Primer Grey (oil based) is required.
7. If the paint comes off easily, then an adhesion test can be done with CCM Rustcon. If this comes off easily, then the surface is not in a suitable condition for painting. Further cleaning may be required or the decision may be taken that the roof is completely unsuitable for painting.
